**RE: Drinking Water Sampling – Potosi Elementary School**  
205 State Hwy P, Potosi, MO 63664  
**Project Number: 923182**

Drinking Water Assessment  
Potosi Elementary School  
Potosi School District

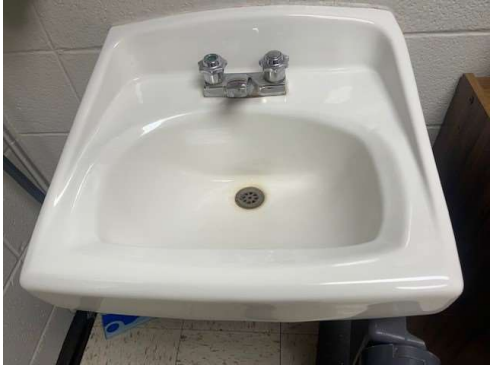
ID:	182-PES-01	Location:	Nurse's Office		
Photo:

Manufacturer:	American Standard		
		Description:			
		Sink			
		Result:	N/A	ppb	
Recommended Action:		Date Sampled:	2/10/2024	By:	BD

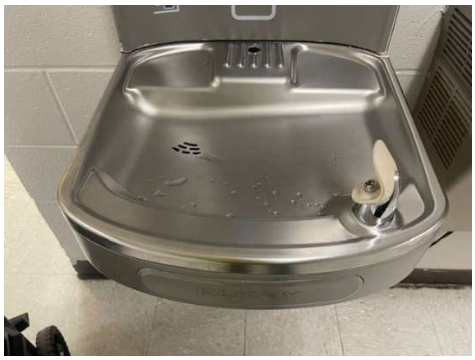
ID:	182-PES-02	Location:	Hallway		
Photo:

Manufacturer:	Elkay		
		Description:			
		East double drinking fountain bubbler across from library			
		Result:	<1.0	ppb	
Recommended Action:		Date Sampled:	2/10/2024	By:	BD

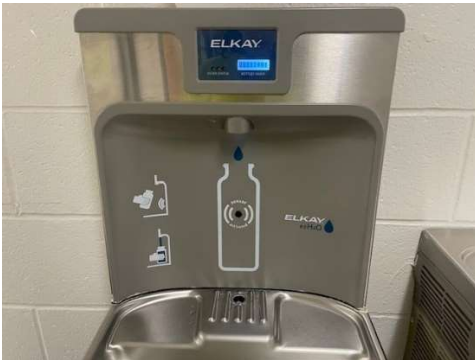
ID:	182-PES-03	Location:	Hallway		
Photo:

Manufacturer:	Elkay		
		Description:			
		East double fountain bottle filler across from library			
		Result:	<1.0	ppb	
Recommended Action:		Date Sampled:	2/10/2024	By:	BD

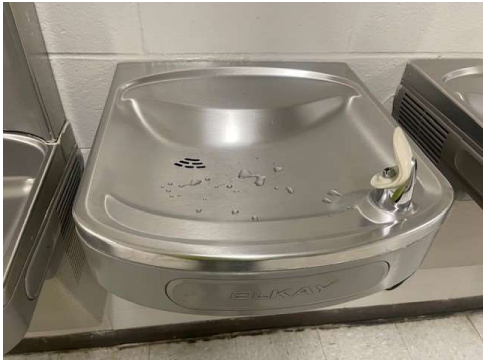
ID:	182-PES-04	Location:	Hallway		
Photo:

Manufacturer:	Elkay		
		Description:			
		East single fountain bubbler			
		Result:	<1.0	ppb	
Recommended Action:		Date Sampled:	2/10/2024	By:	BD

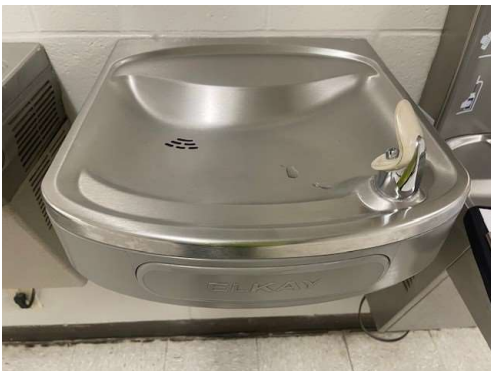
ID:	182-PES-05	Location:	Hallway		
Photo:

Manufacturer:	Elkay		
		Description:			
		West single fountain bubbler			
		Result:	<1.0	ppb	
Recommended Action:		Date Sampled:	2/10/2024	By:	BD

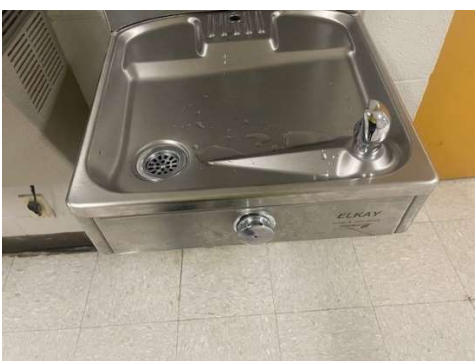
ID:	182-PES-06	Location:	Hallway		
Photo:

Manufacturer:	Elkay		
		Description:			
		West Double fountain bubbler			
		Result:	<1.0	ppb	
Recommended Action:		Date Sampled:	2/10/2024	By:	BD

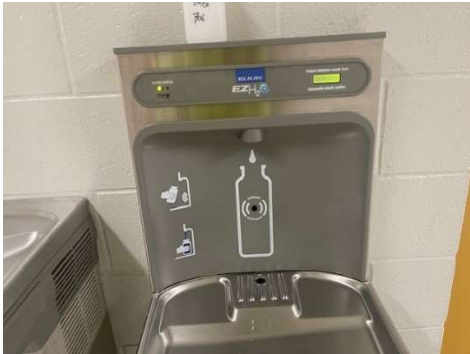
ID:	182-PES-07	Location:	Hallway		
Photo:

Manufacturer:	Elkay		
		Description:			
		West double fountain bottle filler			
		Result:	<1.0	ppb	
Recommended Action:		Date Sampled:	2/10/2024	By:	BD

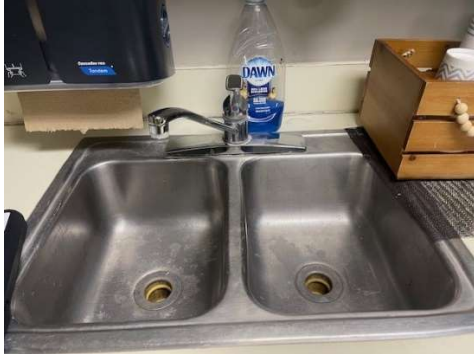
ID:	182-PES-08	Location:	Teacher's Lounge		
Photo:

Manufacturer:	Unknown		
		Description:			
		Sink			
		Result:	1.7	ppb	
Recommended Action:		Date Sampled:	2/10/2024	By:	BD

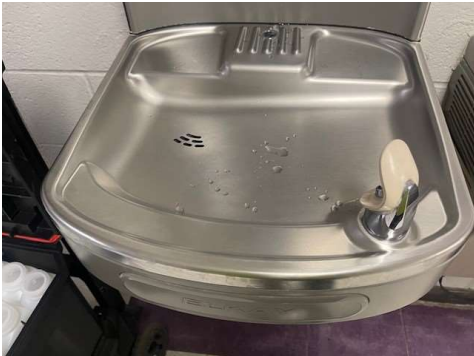
ID:	182-PES-11	Location:	2/3rd grade crosshall		
Photo:

Manufacturer:	Elkay		
		Description:			
		Far left Double fountain bubbler			
		Result:	<1.0 ppb		
Recommended Action:		Date Sampled:	2/10/2024	By:	BD

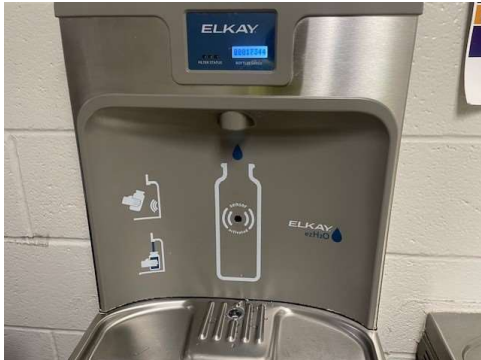
ID:	182-PES-12	Location:	2/3rd grade crosshalll		
Photo:

Manufacturer:	Elkay		
		Description:			
		Far left double fountain bottle filler			
		Result:	N/A ppb		
Recommended Action:		Date Sampled:	2/10/2024	By:	BD

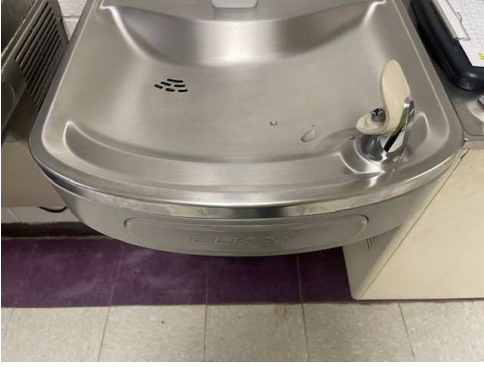
ID:	182-PES-13	Location:	2/3rd grade crosshalll	
Photo:

Manufacturer:	Elkay	
		Description:		
		Left single fountain bubbler		
		Result:	<1.0	ppb
Recommended Action:		Date Sampled:	2/10/2024	By: BD

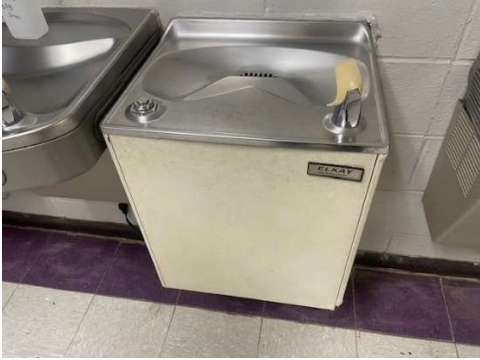
ID:	182-PES-14	Location:	2/3rd grade crosshalll	
Photo:

Manufacturer:	Elkay	
		Description:		
		Right single fountain.		
		Not working at time of test.		
Recommended Action:		Result:	<b>N/A</b>	ppb
		Date Sampled:	2/10/2024	By: BD

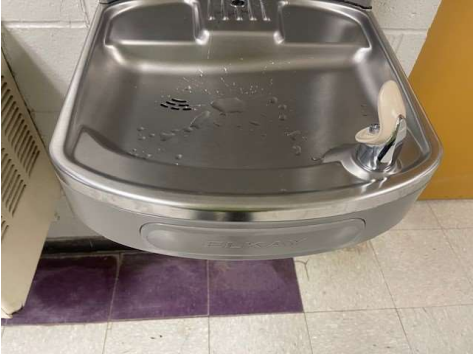
ID:	182-PES-15	Location:	2/3rd grade crosshalll	
Photo:

Manufacturer:	Elkay	
		Description:		
		Right double fountain bubbler		
		Result:	<1.0	ppb
Recommended Action:		Date Sampled:	2/10/2024	By: BD

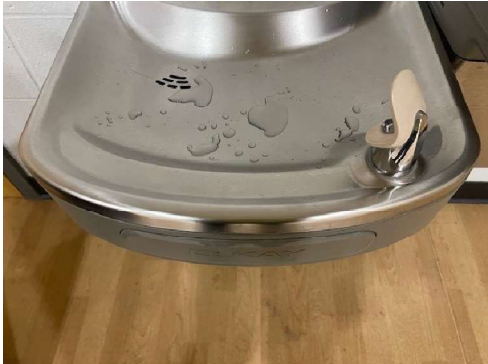
ID:	182-PES-17	Location:	FEMA Building	
Photo:

Manufacturer:	Elkay	
		Description:		
		Single fountain bubbler		
		Result:	<1.0	ppb
Date Sampled:		2/10/2024	By:	BD
Recommended Action:

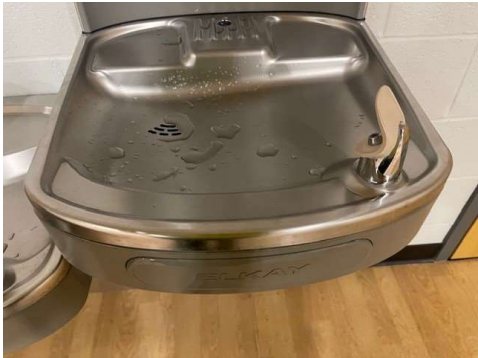
ID:	182-PES-18	Location:	FEMA Building	
Photo:

Manufacturer:	Elkay	
		Description:		
		Double fountain bubbler		
		Result:	<1.0	ppb
Date Sampled:		2/10/2024	By:	BD
Recommended Action:

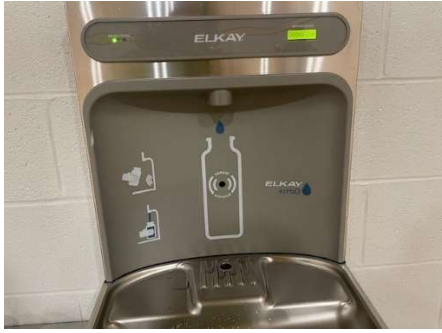
ID:	182-PES-19	Location:	FEMA Building		
Photo:

Manufacturer:	Elkay		
		Description:			
		Double fountain bottle filler			
		Result:	<1.0	ppb	
Recommended Action:		Date Sampled:	2/10/2024	By:	BD

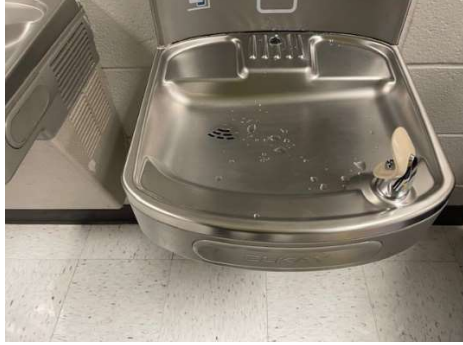
ID:	182-PES-20	Location:	Hallway		
Photo:

Manufacturer:	Elkay		
		Description:			
		Double fountain bubbler across from office			
		Result:	1.1	ppb	
Recommended Action:		Date Sampled:	2/10/2024	By:	BD

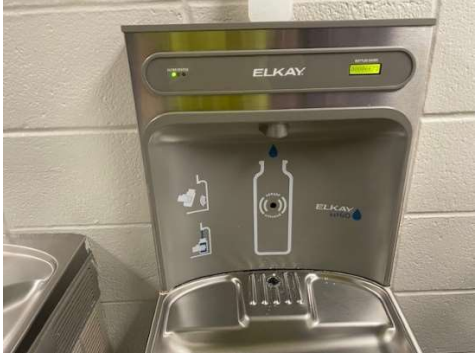
ID:	182-PES-21	Location:	Hallway		
Photo:

Manufacturer:	Elkay		
		Description:			
		Double fountain bottle filler across from office			
		Result:	1.6	ppb	
Recommended Action:		Date Sampled:	2/10/2024	By:	BD

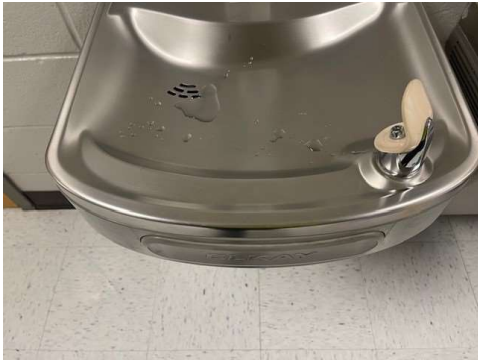
ID:	182-PES-22	Location:	Hallway		
Photo:

Manufacturer:	Elkay		
		Description:			
		Single fountain bubbler across from office			
		Result:	<1.0	ppb	
Recommended Action:		Date Sampled:	2/10/2024	By:	BD

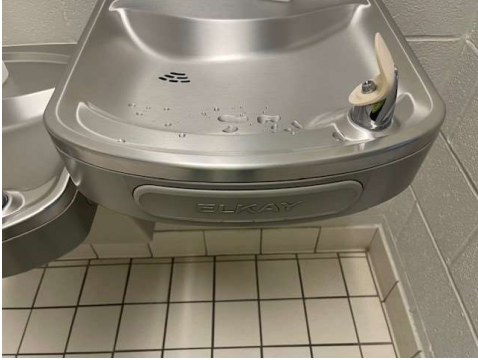
ID:	182-PES-23	Location:	Early Childhood		
Photo:

Manufacturer:	Elkay		
		Description:			
		Girls restroom right fountain			
		Result:	<1.0	ppb	
Recommended Action:		Date Sampled:	2/10/2024	By:	BD

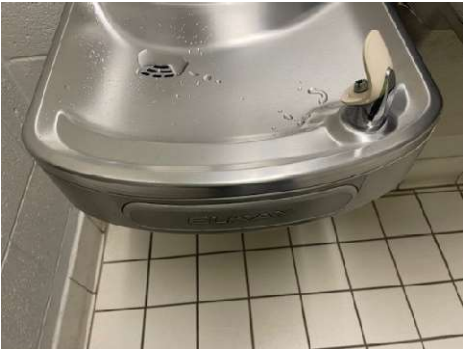
ID:	182-PES-25	Location:	Early Childhood		
Photo:

Manufacturer:	Elkay		
		Description:			
		Boys restroom left single fountain bubbler			
		Result:	<1.0	ppb	
Recommended Action:		Date Sampled:	2/10/2024	By:	BD

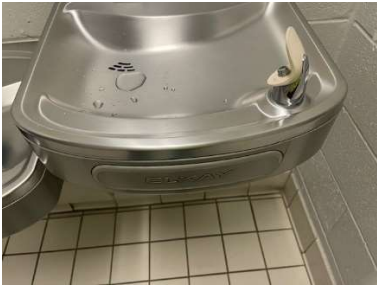
ID:	182-PES-26	Location:	Early Childhood		
Photo:

Manufacturer:	Elkay		
		Description:			
		Boys restroom right single fountain bubbler			
		Result:	<1.0	ppb	
Recommended Action:		Date Sampled:	2/10/2024	By:	BD

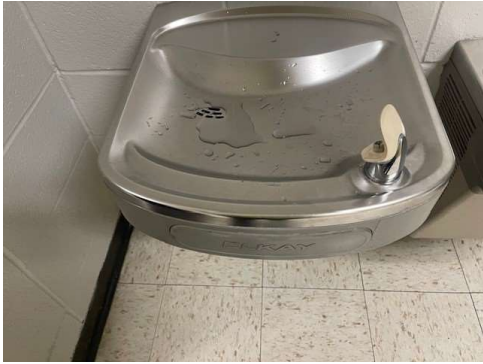
ID:	182-PES-27	Location:	Hallway		
Photo:

Manufacturer:	Elkay		
		Description:			
		Across from multi-purpose room left fountain bubbler			
		Result:	<1.0	ppb	
Recommended Action:		Date Sampled:	2/10/2024	By:	BD

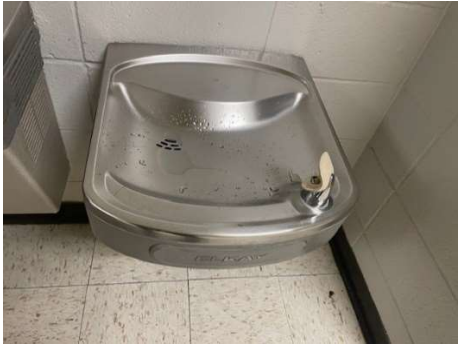
ID:	182-PES-28	Location:	Hallway		
Photo:

Manufacturer:	Elkay		
		Description:			
		Across from multi-purpose room right fountain bubbler			
		Result:	<1.0	ppb	
Recommended Action:		Date Sampled:	2/10/2024	By:	BD

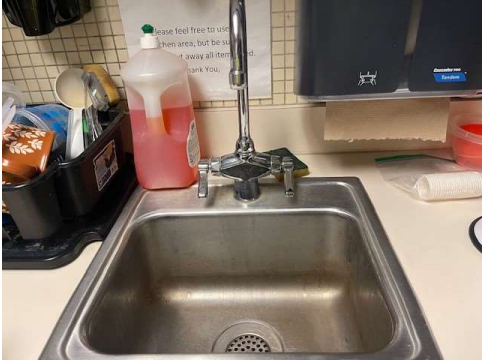
ID:	182-PES-29	Location:	Office		
Photo:

Manufacturer:	Chicago Faucet Co.		
		Description:			
		Sink			
		Result:	4.9	ppb	
Recommended Action:		Date Sampled:	2/10/2024	By:	BD

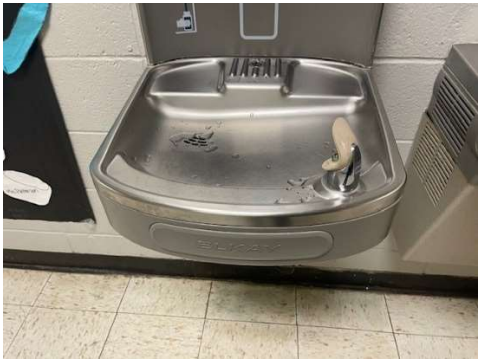
ID:	182-PES-30	Location:	Hallway		
Photo:

Manufacturer:	Elkay		
		Description:			
		Left double fountain bubbler outside of kitchen			
		Result:	<1.0	ppb	
Recommended Action:		Date Sampled:	2/10/2024	By:	BD

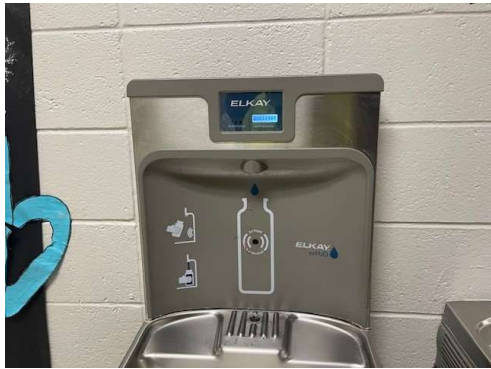
ID:	182-PES-31	Location:	Hallway	
Photo:

Manufacturer:	Elkay	
		Description:		
		left double fountain bubbler outside of kitchen		
		Result:	<1.0	ppb
Recommended Action:		Date Sampled:	2/10/2024	By: BD

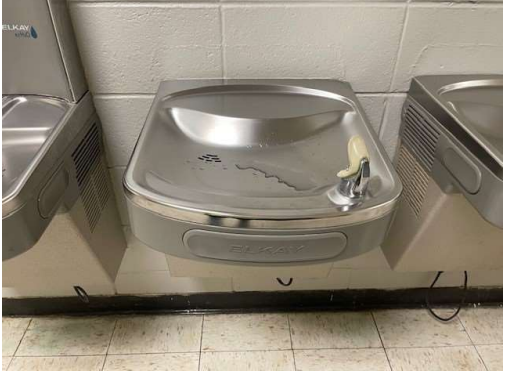
ID:	182-PES-32	Location:	Hallway	
Photo:

Manufacturer:	Elkay	
		Description:		
		Left single fountain bubbler		
		Result:	<1.0	ppb
Recommended Action:		Date Sampled:	2/10/2024	By: BD

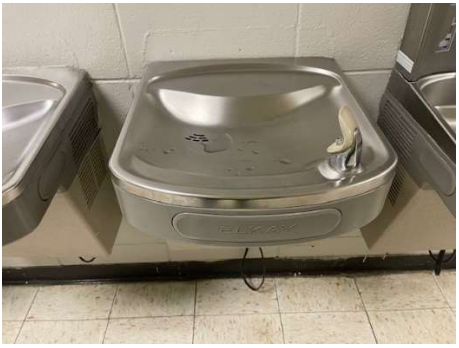
ID:	182-PES-33	Location:	Hallway	
Photo:

Manufacturer:	Elkay	
		Description:		
		Right single fountain bubbler		
		Result:	1.1	ppb
Recommended Action:		Date Sampled:	2/10/2024	By: BD

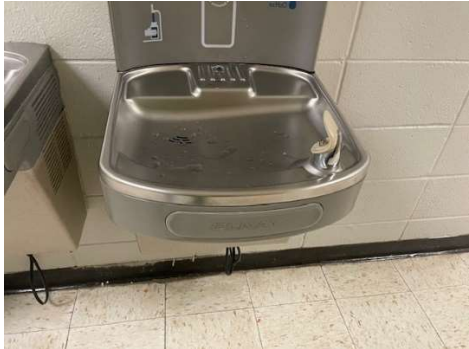
ID:	182-PES-34	Location:	Hallway		
Photo:

Manufacturer:	Elkay		
		Description:			
		Right double fountain bubbler outside of kitchen			
		Result:	<1.0	ppb	
Recommended Action:		Date Sampled:	2/10/2024	By:	BD

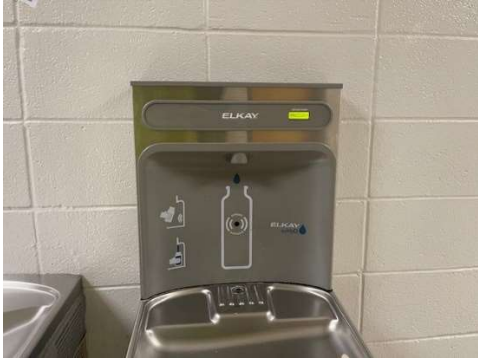
ID:	182-PES-35	Location:	Hallway		
Photo:

Manufacturer:	Elkay		
		Description:			
		Double fountain bottle filler outside of kitchen			
		Result:	<1.0	ppb	
Recommended Action:		Date Sampled:	2/10/2024	By:	BD

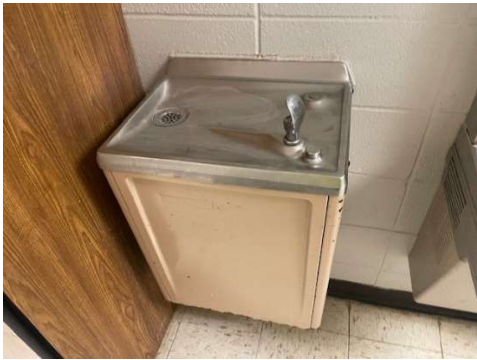
ID:	182-PES-36	Location:	Hallway		
Photo:

Manufacturer:	Unknown		
		Description:			
		Across from room 52 left single fountain bubbler			
		Result:	<1.0	ppb	
Recommended Action:		Date Sampled:	2/10/2024	By:	BD

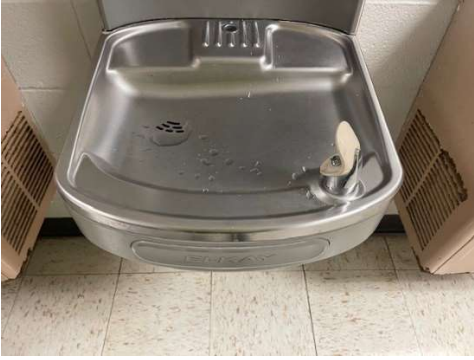
ID:	182-PES-37	Location:	Hallway		
Photo:

Manufacturer:	Elkay		
		Description:			
		Across from room 52 double fountain bubbler			
		Result:	<1.0	ppb	
Recommended Action:		Date Sampled:	2/10/2024	By: BD

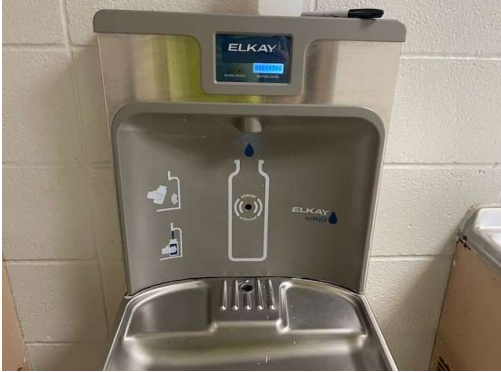
ID:	182-PES-38	Location:	Hallway		
Photo:

Manufacturer:	Elkay		
		Description:			
		Across from room 52 double fountain bottle filler			
		Result:	<1.0	ppb	
Recommended Action:		Date Sampled:	2/10/2024	By: BD

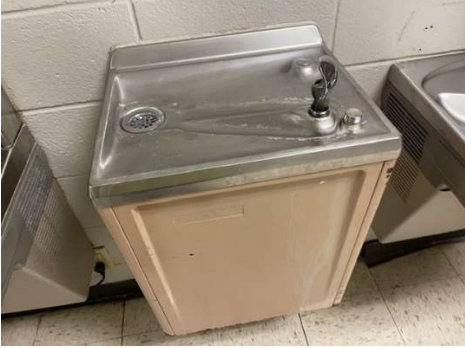
ID:	182-PES-39	Location:	Hallway		
Photo:

Manufacturer:	Elkay		
		Description:			
		Across from room 52 single fountain bubbler			
		Did not work at time of test			
Recommended Action:		Result:	<b>NA</b>	ppb	
		Date Sampled:	2/10/2024	By: BD

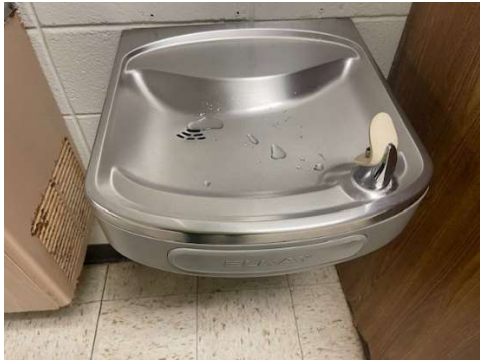
ID:	182-PES-40	Location:	Hallway		
Photo:

Manufacturer:	Elkay		
		Description:			
		Across from room 52 single fountain bubbler			
		Result:	<1.0	ppb	
Recommended Action:		Date Sampled:	2/10/2024	By:	BD

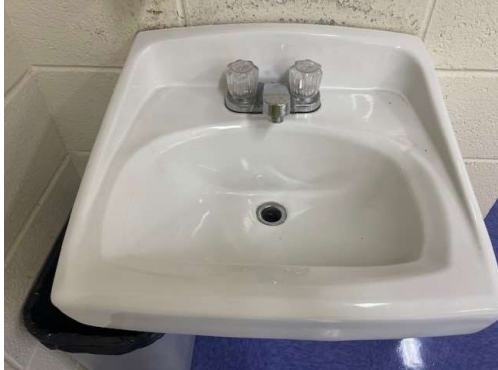
ID:	182-PES-41	Location:	Kitchen		
Photo:

Manufacturer:	Unknown		
		Description:			
		Shandwashing sink on East wall			
		Result:	1.7	ppb	
Recommended Action:		Date Sampled:	2/10/2024	By:	BD

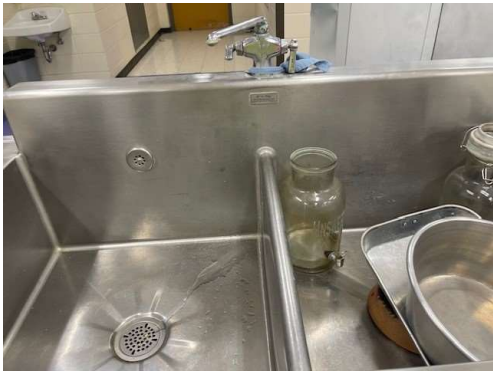
ID:	182-PES-42	Location:	Kitchen		
Photo:

Manufacturer:	Unknown		
		Description:			
		Prep sink East side			
		Result:	<b>7.9</b>	ppb	
Recommended Action:		Date Sampled:	2/10/2024	By:	BD
		<b>Replace Fixture/Unit and Resample</b>

In accordance with the requirements set forth in Missouri Bill 681/662, fixtures exhibiting lead concentrations above 5 ppb must be remediated by replacement of lead-containing pipes, solder, fittings or fixtures with lead-free components, or the school shall install filtration at each point where water enters the building until such time as the source can be remediated. If installing a filter is not feasible, the school shall provide purified water at each outlet inventoried.

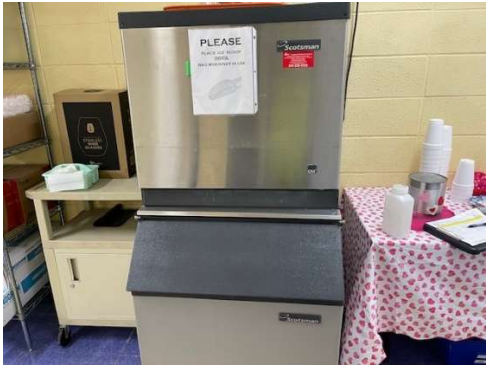
ID:	182-PES-43	Location:	Kitchen	
Photo:

Manufacturer:	Scotsman	
		Description:		
		Icemachine		
		Result:	<1.0	ppb
Recommended Action:		Date Sampled:	2/10/2024	By: BD

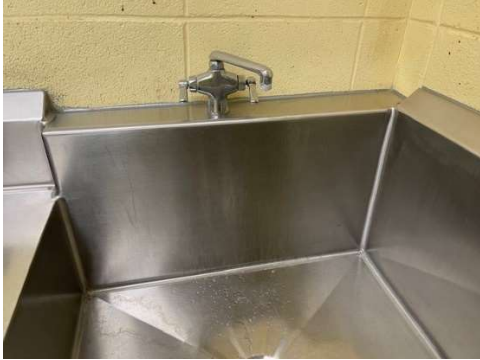
ID:	182-PES-44	Location:	Kitchen	
Photo:

Manufacturer:	Unknown	
		Description:		
		East room sink, not used and was not flushed prior		
		Result:	<b>352</b>	ppb
Recommended Action:		Date Sampled:	2/10/2024	By: BD
<b>Replace Fixture/Unit and Resample</b>

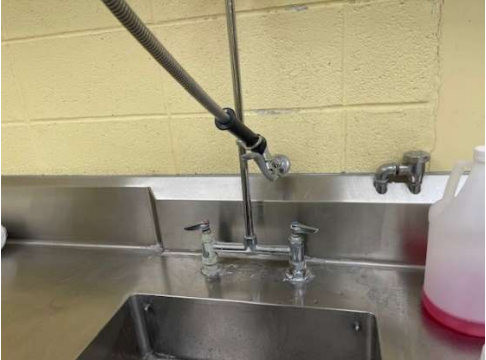
ID:	182-PES-45	Location:	Kitchen	
Photo:

Manufacturer:	Unknown	
		Description:		
		Kitchen dish sprayer in East room, not used, was not flushed prior		
		Result:	<b>164</b>	ppb
Recommended Action:		Date Sampled:	2/10/2024	By: BD
<b>Replace Fixture/Unit and Resample</b>

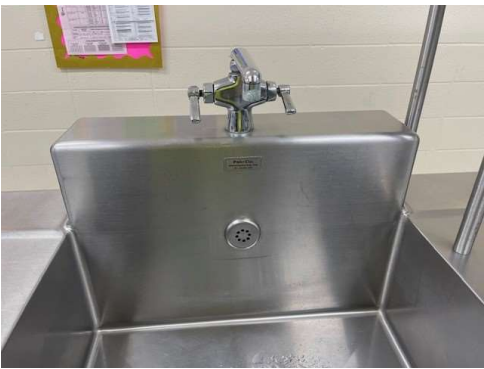
ID:	182-PES-46	Location:	Kitchen	
Photo:

Manufacturer:	Unknown	
		Description:		
		Sink on south side of kitchen		
		Result:	<b>7.2</b>	ppb
Recommended Action:		<b>Replace Fixture/Unit and Resample</b>		
Date Sampled:	2/10/2024	By:	BD

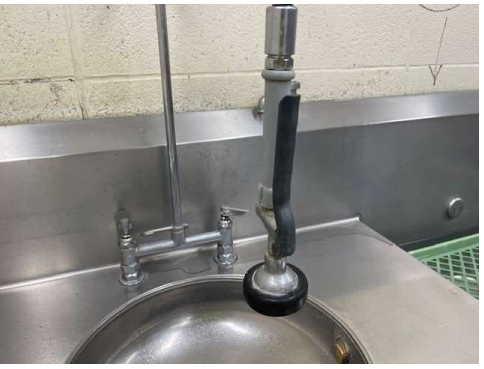
ID:	182-PES-47	Location:	Kitchen	
Photo:

Manufacturer:	Unknown	
		Description:		
		West wall kitchen dish sprayer		
		Result:	<1.0	ppb
Recommended Action:				
Date Sampled:	2/10/2024	By:	BD

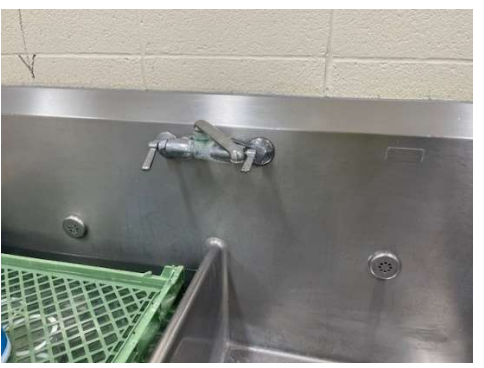
ID:	182-PES-48	Location:	Kitchen	
Photo:

Manufacturer:	Unknown	
		Description:		
		West wall, left sink		
		Result:	1.7	ppb
Recommended Action:				
Date Sampled:	2/10/2024	By:	BD

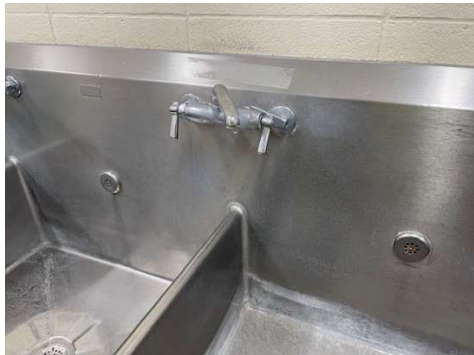
ID:	182-PES-49	Location:	Kitchen	
Photo:

Manufacturer:	Unknown	
		Description:		
		Right sink, was leaking at time of test		
		Result:	2.5	ppb
Recommended Action:		Date Sampled:	2/10/2024	By: BD

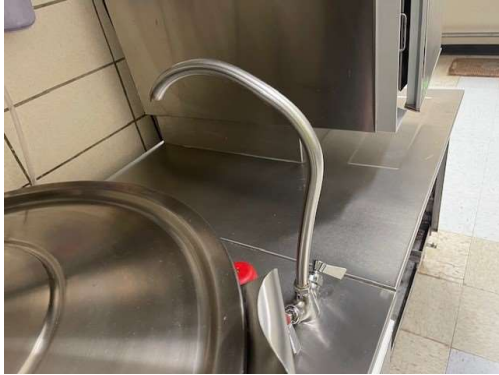
ID:	182-PES-50	Location:	Kitchen	
Photo:

Manufacturer:	Unknown	
		Description:		
		Pot filler		
		Result:	4.7	ppb
Recommended Action:		Date Sampled:	2/10/2024	By: BD

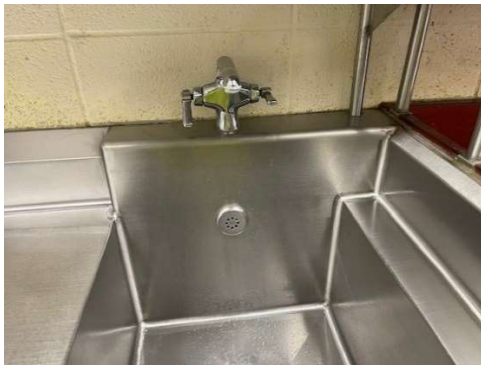
ID:	182-PES-51	Location:	Kitchen	
Photo:

Manufacturer:	Unknown	
		Description:		
		North wall sink		
		Result:	<b>7.4</b>	ppb
Recommended Action:		Date Sampled:	2/10/2024	By: BD
		<b>Replace Fixture/Unit and Resample</b>

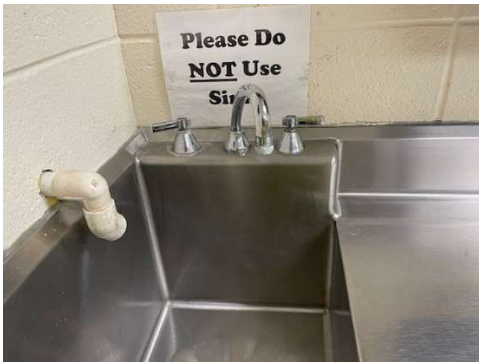
ID:	182-PES-52	Location:	Kitchen	
Photo:

Manufacturer:	Unknown	
		Description:		
		Near food line West side sink		
		Result:	<b>5.7</b>	ppb
Recommended Action:		<b>Replace Fixture/Unit and Resample</b>		
		Date Sampled:	2/10/2024	By: BD

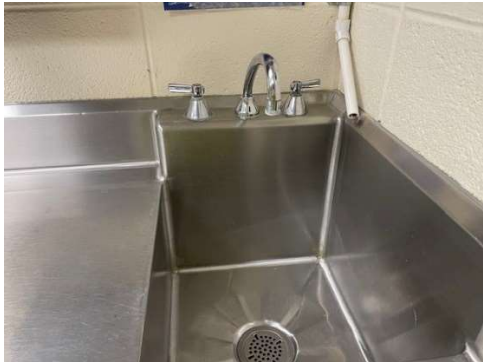
ID:	182-PES-53	Location:	Kitchen	
Photo:

Manufacturer:	Unknown	
		Description:		
		near food line East side sink		
		Result:	<b>6.4</b>	ppb
Recommended Action:		<b>Replace Fixture/Unit and Resample</b>		
		Date Sampled:	2/10/2024	By: BD
