RE: Drinking Water Sampling – Potosi High School
1 Trojan Dr, Potosi, MO 63664
Project Number: 923182

Drinking Water Assessment
Potosi High school
Potosi School District

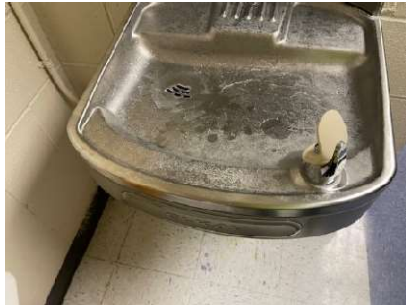
| ID: | 182-PHS-01 | Location: | Wrestling Room | |

| | | Drinking fountain bubbler | | |
| | | Result: | 1.6 | ppb |

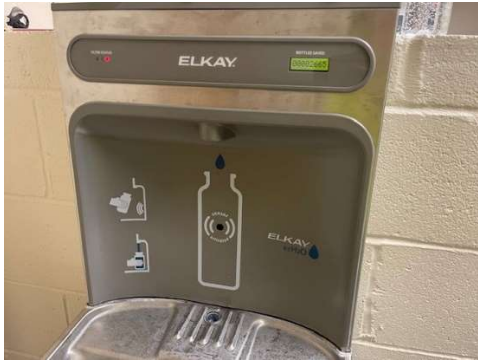
| ID: | 182-PHS-02 | Location: | Wrestling Room | |

| | | Drinking fountain bottle filler | | |
| | | Result: | 2 | ppb |

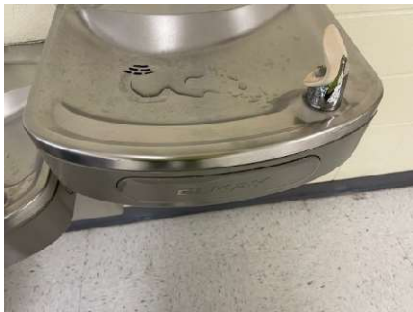
| ID: | 182-PHS-03 | Location: | AD wing | |

| | | End of hallway by custodial room left fountain bubbler | | |
| | | Result: | <1.0 | ppb |

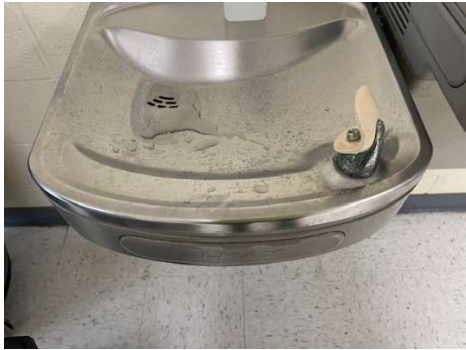
| ID: | 182-PHS-04 | Location: | AD wing | | |

| | | End of hallway by custodial room right fountain bubbler | | | |
| | | Result: | <1.0 | ppb | |

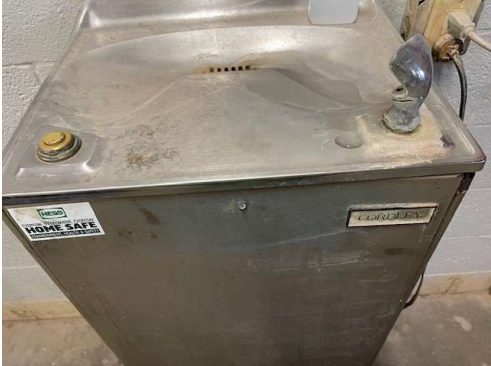
| ID: | 182-PHS-05 | Location: | Woodshop | | |

| | | Drinking fountain bubbler | | | |
| | | Result: | 2.5 | ppb | |

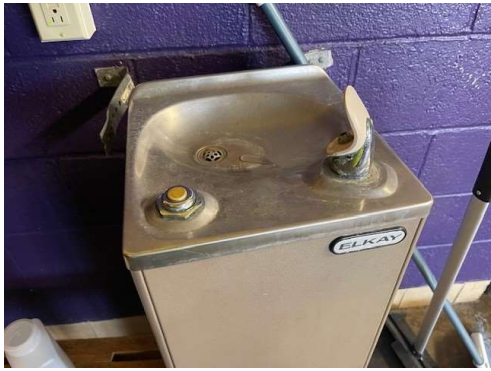
| ID: | 182-PHS-06 | Location: | Football locker room | | |

| Sample ID | Location | Type | Result (ug/L) |
|---|---|---|---|
| 182-PHS-06 | Football Locker room | Drinking Fountain Bubblers | 7.5 |

| | | Drinking fountain bubbler | | | |
| | | Result: | 7.5 | ppb | |

| Recommended Action: | | Replace Fixture/Unit and Resample | | | |

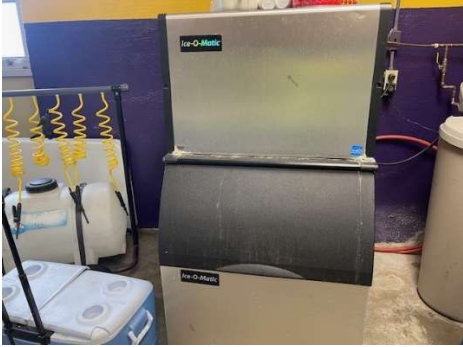
| ID: | 182-PHS-07 | Location: | Football Locker room |

| | | Ice machine | |
| | | Result: | <1.0 |

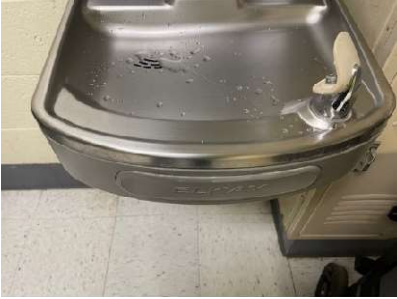
| ID: | 182-PHS-08 | Location: | Hallway |

| | | Drinking fountain bubbler across from main gym | |
| | | Result: | <1.0 |

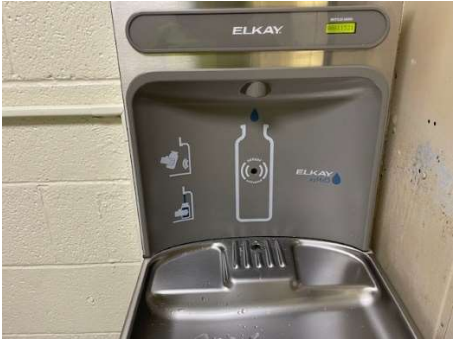
| ID: | 182-PHS-09 | Location: | Hallway |

| Sample ID | Location | Type | Result (ug/L) |
|---|---|---|---|
| 182-PHS-09 | Hallway | Water Bottle Filler | 32 |

| | | Drinking fountain bottle filler across from main gym | |
| | | Result: | 32 |

| | | Install End of line Filter and Resample | |

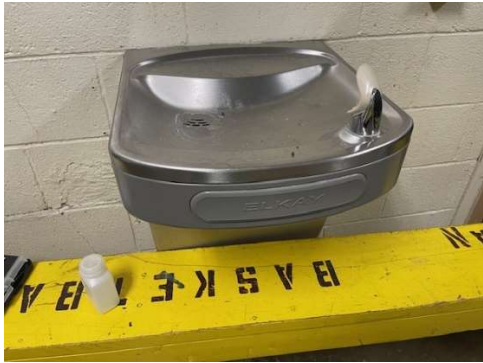
| ID: | 182-PHS-10 | Location: | Boys gym |

| | | Lockerroom | |
| | | Not working at time of test. | |
| Result: | | N/A | ppb |

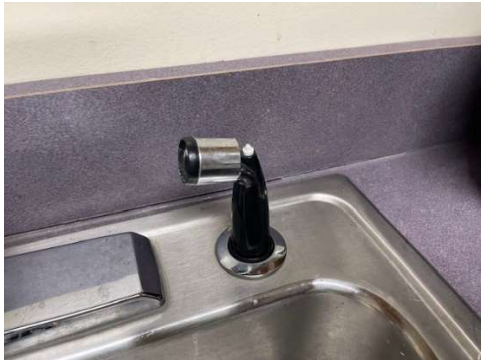
| ID: | 182-PHS-16 | Location: | Basketball concessions |

| | | Sink sprayer | |
| | | Not working at time of test. | |
| Result: | | NA | ppb |

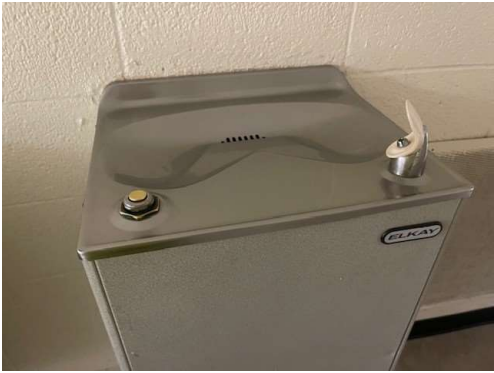
| ID: | 182-PHS-32 | Location: | Hallway | | |

| | | Right drinking fountain bubbler outside of cafeteria | | | |
| Recommended Action: | | Result: | N/A | ppb | |

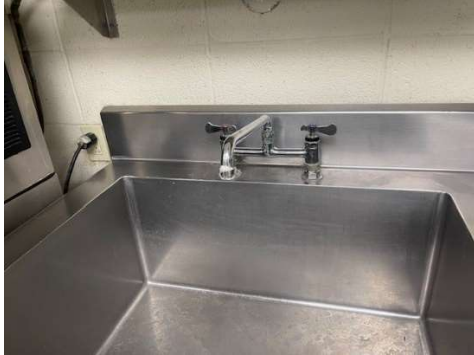
| ID: | 182-PHS-35 | Location: | Kitchen |

| Sample ID | Location | Type | Result (ug/L) |
|---|---|---|---|
| 182-PHS-35 | Kitchen | Kitchen | 9.6 |

| | | Sink next to ice machine | |

| Recommended Action: | | Replace Fixture/Unit and Resample | |

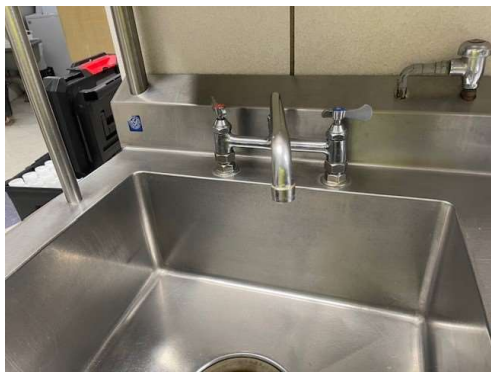
| ID: | 182-PHS-36 | Location: | Kitchen |

| Sample ID | Location | Type | Result (ug/L) |
|---|---|---|---|
| 182-PHS-36 | Kitchen | Sink | 15.4 |

| | | Sink near hanging utensils | |
| | | Leaking at time of test. | |

| Recommended Action: | | Replace Fixture/Unit and Resample | |

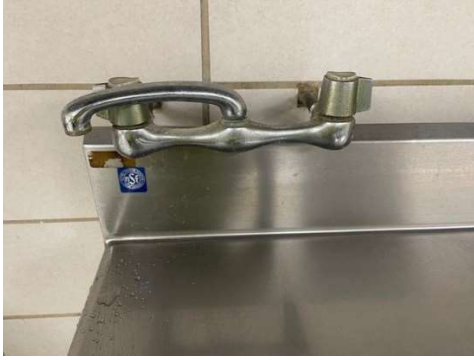
| ID: | 182-PHS-37 | Location: | Kitchen | |

| Sample ID | Location | Type | Result (ug/L) |
|---|---|---|---|
| 182-PHS-37 | Kitchen | Pot Filler | 496 |

| | | Stationary Pot Filler | | |

| Recommended Action: | | Replace Fixture/Unit and Resample | | |

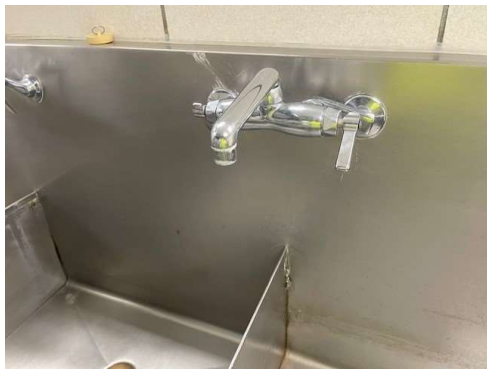
| ID: | 182-PHS-39 | Location: | Kitchen | |

| Sample ID | Location | Type | Result (ug/L) |
|---|---|---|---|
| 182-PHS-39 | Kitchen | Sink | 13 |

| | | North island right sink | | |

| Recommended Action: | | Replace Fixture/Unit and Resample | | |

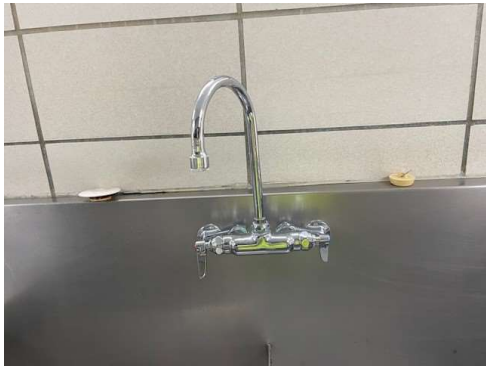
| ID: | 182-PHS-40 | Location: | Kitchen | |

| Sample ID | Location | Type | Result (ug/L) |
|---|---|---|---|
| 182-PHS-40 | Kitchen | Sink | 13 |

| | | Left sink in North island | | |

| Recommended Action: | | Replace Fixture/Unit and Resample | | |

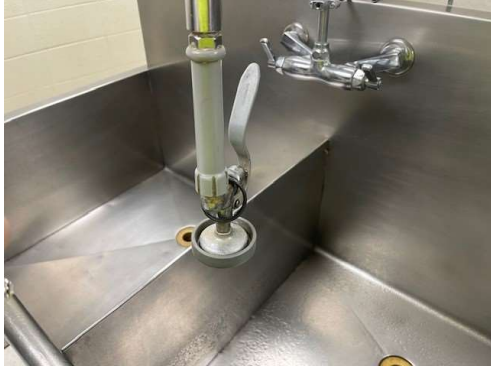
| ID: | 182-PHS-41 | Location: | Kitchen | |

| Sample ID | Location | Type | Result (ug/L) |
|---|---|---|---|
| 182-PHS-41 | Kitchen | Kitchen Dish Sprayer | 5 |

| | | North island, left kitchen dish sprayer | | |

| Recommended Action: | | Replace Fixture/Unit and Resample | | |

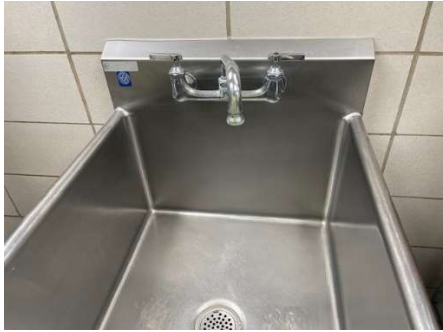
| ID: | 182-PHS-42 | Location: | Kitchen | |

| Sample ID | Location | Type | Result (ug/L) |
|---|---|---|---|
| 182-PHS-42 | Kitchen | Sink | 6 |

| | | North side next to mixer, stand alone sink | | |

| Recommended Action: | | Replace Fixture/Unit and Resample | | |

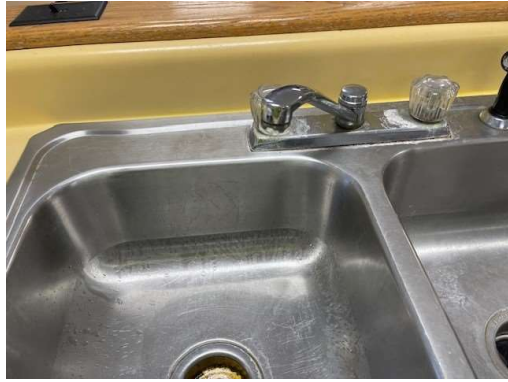
| ID: | 182-PHS-49 | Location: | Food's room |

| Sample ID | Location | Type | Result (ug/L) |
|---|---|---|---|
| 182-PHS-49 | Food's Room | Sink | 9 |

| | | Yellow kitchen sink | |

| Recommended Action: | | Replace Fixture/Unit and Resample | |

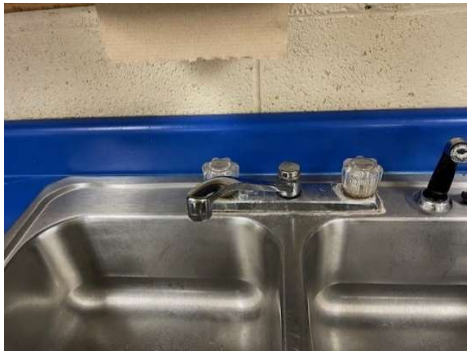
| ID: | 182-PHS-51 | Location: | Food's room | |

| Sample ID | Location | Type | Result (ug/L) |
|---|---|---|---|
| 182-PHS-51 | Food's Room | Sink | 7.3 |

| | | Blue kitchen sink | | |

| | | Replace Fixture/Unit and Resample | | |
