RE: Drinking Water Sampling – Potosi Intermediate School
367 Intermediate Dr, Potosi, MO 63664
Project Number: 923182

Drinking Water Assessment
Potosi Intermediate School
Potosi School District

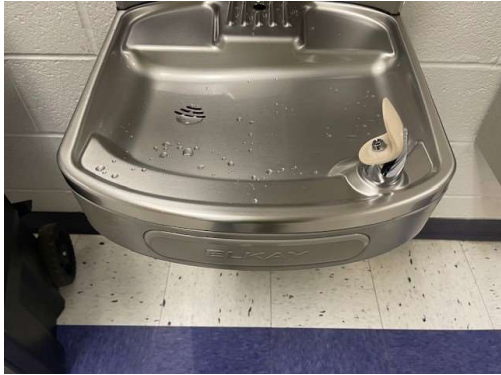
ID:	182-PIM-01	Location:	Hallway		
Photo:

Manufacturer:	Elkay		
		Description:			
		Double drinking fountain bubbler across from room 606			
		Result:	<1.0	ppb	
Recommended Action:		Date Sampled:	2/10/2024	By:	BD

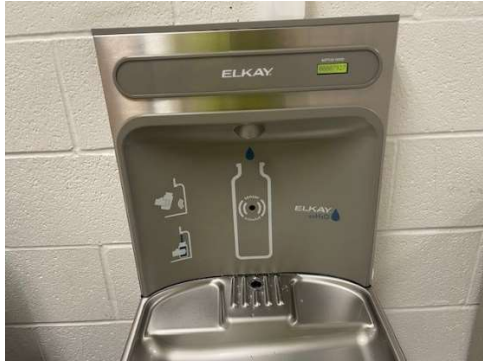
ID:	182-PIM-02	Location:	Hallway		
Photo:

Manufacturer:	Elkay		
		Description:			
		Double drinking fountain bottle filler across from room 606			
		Result:	<1.0	ppb	
Recommended Action:		Date Sampled:	2/10/2024	By:	BD

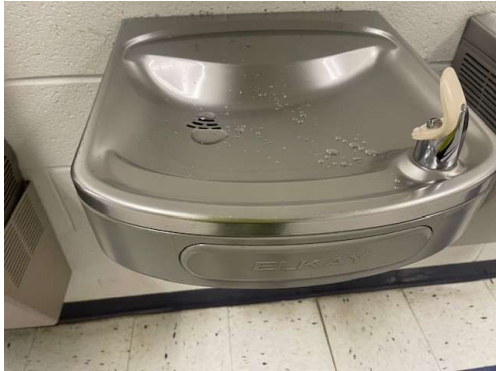
ID:	182-PIM-03	Location:	Hallway		
Photo:

Manufacturer:	Elkay		
		Description:			
		Left single drinking fountain bubbler across from room 606			
		Result:	<1.0	ppb	
Recommended Action:		Date Sampled:	2/10/2024	By:	BD

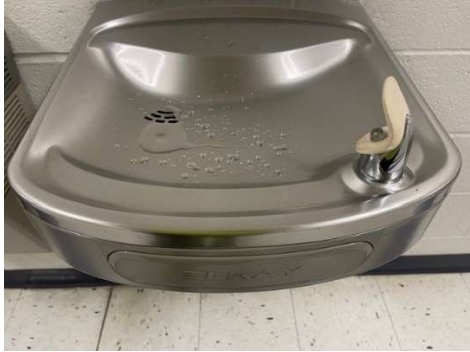
ID:	182-PIM-04	Location:	Hallway		
Photo:

Manufacturer:	Elkay		
		Description:			
		Right single fountain bubbler across from room 606			
		Result:	<1.0	ppb	
Recommended Action:		Date Sampled:	2/10/2024	By:	BD

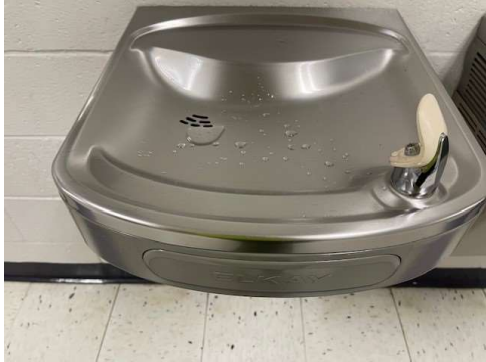
ID:	182-PIM-05	Location:	Hallway		
Photo:

Manufacturer:	Elkay		
		Description:			
		Left single fountain bubbler near cafeteria			
		Result:	<1.0	ppb	
Recommended Action:		Date Sampled:	2/10/2024	By:	BD

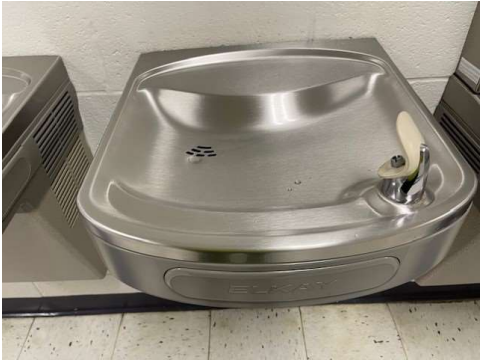
ID:	182-PIM-06	Location:	Hallway		
Photo:

Manufacturer:	Elkay		
		Description:			
		Right single fountain bubbler near cafeteria			
		Result:	<1.0	ppb	
Recommended Action:		Date Sampled:	2/10/2024	By:	BD

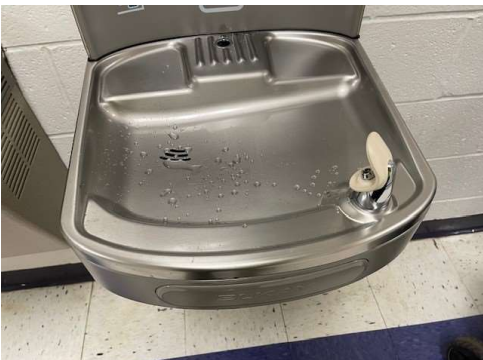
ID:	182-PIM-07	Location:	Hallway	
Photo:

Manufacturer:	Elkay	
		Description:		
		Left double fountain bubbler near cafeteria		
		Result:	<1.0	ppb
Date Sampled:		2/10/2024	By:	BD
Recommended Action:

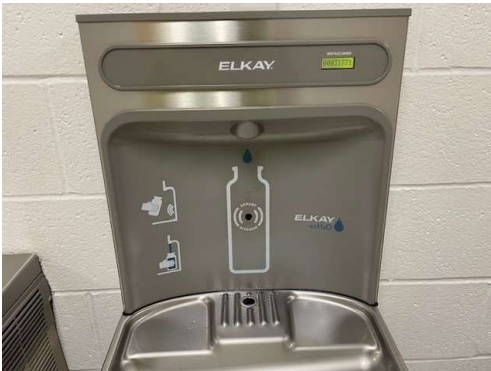
ID:	182-PIM-08	Location:	Hallway	
Photo:

Manufacturer:	Elkay	
		Description:		
		Left double fountain bottle filler near cafeteria		
		Result:	<1.0	ppb
Date Sampled:		2/10/2024	By:	BD
Recommended Action:

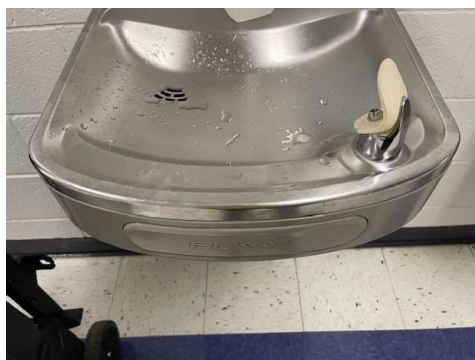
ID:	182-PIM-09	Location:	Hallway	
Photo:

Manufacturer:	Elkay	
		Description:		
		Left single fountain bubbler near Susan's custodial closet		
		Result:	<1.0	ppb
Date Sampled:		2/10/2024	By:	BD
Recommended Action:

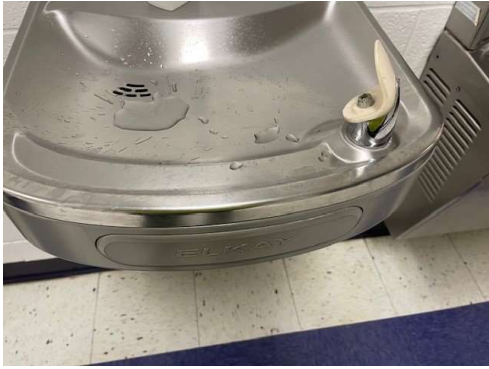
ID:	182-PIM-10	Location:	Hallway		
Photo:

Manufacturer:	Elkay		
		Description:			
		Right single drinking fountain bubbler near Susan's Custodial closet			
		Result:	<1.0	ppb	
Recommended Action:		Date Sampled:	2/10/2024	By:	BD

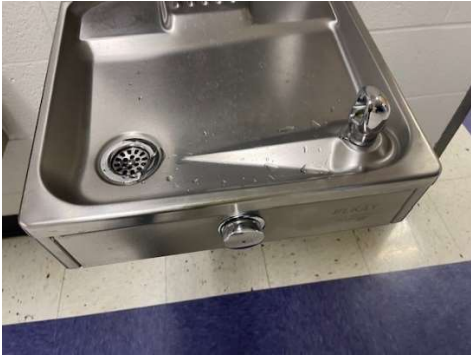
ID:	182-PIM-11	Location:	Hallway		
Photo:

Manufacturer:	Elkay		
		Description:			
		Right double fountain bubbler near Susan's Custodial closet			
		Result:	<1.0	ppb	
Recommended Action:		Date Sampled:	2/10/2024	By:	BD

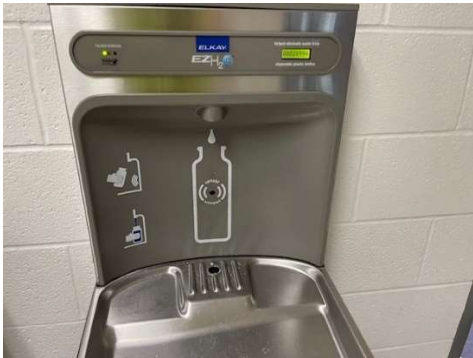
ID:	182-PIM-12	Location:	Hallway		
Photo:

Manufacturer:	Elkay		
		Description:			
		Right double fountain bottle filler near Susan's Custodial closet			
		Result:	<1.0	ppb	
Recommended Action:		Date Sampled:	2/10/2024	By:	BD

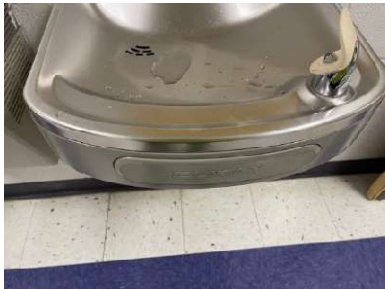
ID:	182-PIM-13	Location:	Hallway		
Photo:

Manufacturer:	Elkay		
		Description:			
		Right single drinking fountain bubbler near room 507			
		Result:	<1.0	ppb	
Recommended Action:		Date Sampled:	2/10/2024	By:	BD

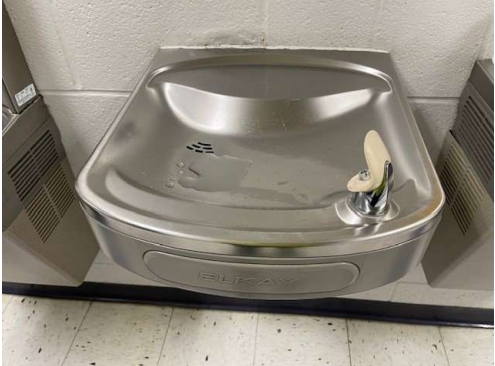
ID:	182-PIM-14	Location:	Hallway		
Photo:

Manufacturer:	Elkay		
		Description:			
		Left single drinking fountain bubbler near room 507			
		Result:	<1.0	ppb	
Recommended Action:		Date Sampled:	2/10/2024	By:	BD

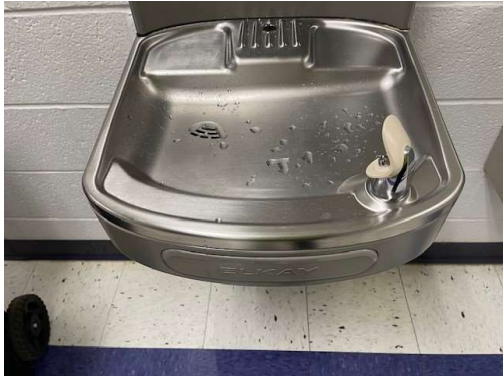
ID:	182-PIM-15	Location:	Hallway		
Photo:

Manufacturer:	Elkay		
		Description:			
		Left double fountain bubbler next to room 507			
		Result:	<1.0	ppb	
Recommended Action:		Date Sampled:	2/10/2024	By:	BD

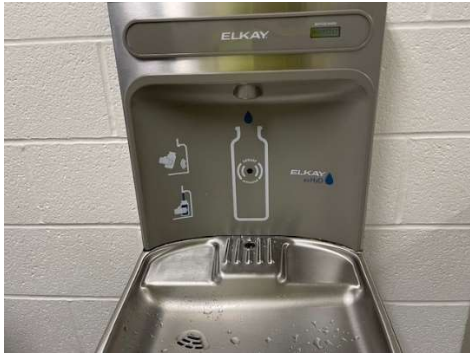
ID:	182-PIM-16	Location:	Hallway
Photo:

Manufacturer:	Elkay
		Description:	
		Left double fountain bottle filler next to room 507	
		Result:	<1.0
Recommended Action:		Date Sampled:	2/10/2024
		By:	BD

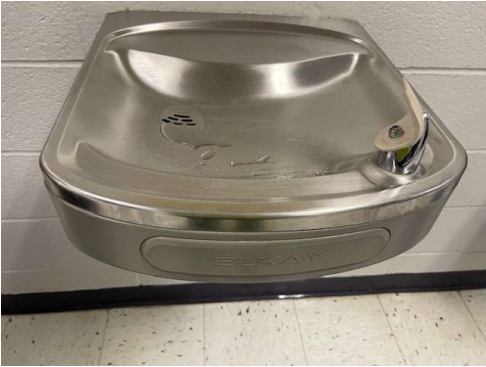
ID:	182-PIM-17	Location:	Hallway
Photo:

Manufacturer:	Elkay
		Description:	
		left drinking fountain bubbler next to Library	
		Result:	<1.0
Recommended Action:		Date Sampled:	2/10/2024
		By:	BD

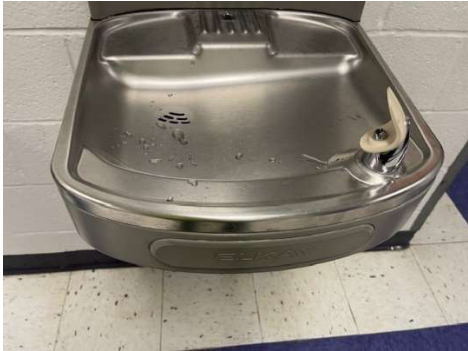
ID:	182-PIM-18	Location:	Hallway
Photo:

Manufacturer:	Elkay
		Description:	
		Right drinking fountain bubbler next to Library	
		Result:	<1.0
Recommended Action:		Date Sampled:	2/10/2024
		By:	BD

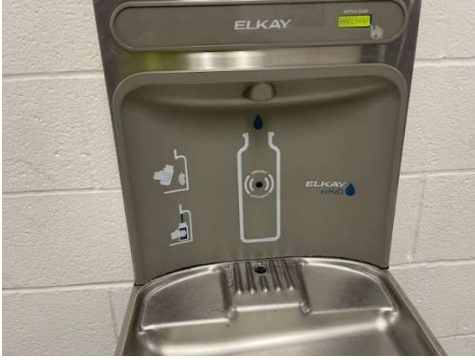
ID:	182-PIM-19	Location:	Hallway		
Photo:

Manufacturer:	Elkay		
		Description:			
		Right drinking fountain bottle filler next to Library			
		Result:	<1.0	ppb	
Recommended Action:		Date Sampled:	2/10/2024	By:	BD

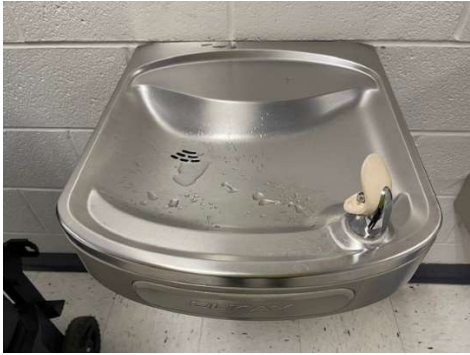
ID:	182-PIM-20	Location:	Hallway		
Photo:

Manufacturer:	Elkay		
		Description:			
		Left single drinking fountain bubbler next to room 407			
		Result:	<1.0	ppb	
Recommended Action:		Date Sampled:	2/10/2024	By:	BD

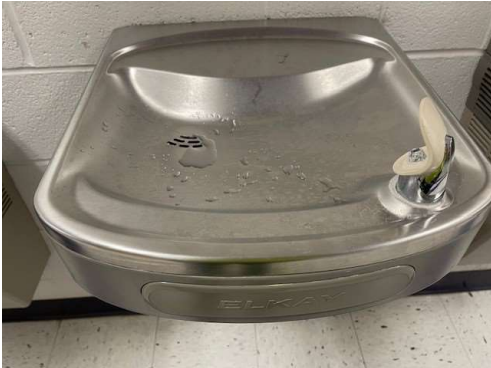
ID:	182-PIM-21	Location:	hallway		
Photo:

Manufacturer:	Elkay		
		Description:			
		Right single drinking fountain bubbler next to room 407			
		Result:	<1.0	ppb	
Recommended Action:		Date Sampled:	2/10/2024	By:	BD

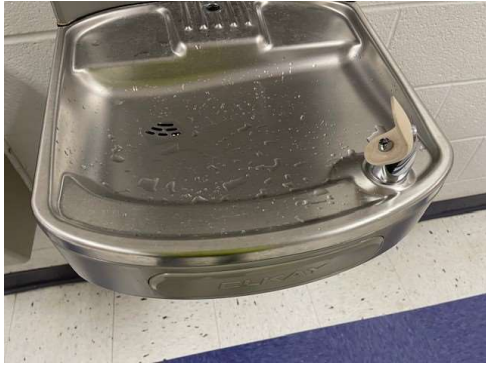
ID:	182-PIM-22	Location:	Hallway		
Photo:

Manufacturer:	Elkay		
		Description:			
		Right drinking fountain bubbler next to room 407			
		Result:	<1.0	ppb	
Recommended Action:		Date Sampled:	2/10/2024	By:	BD

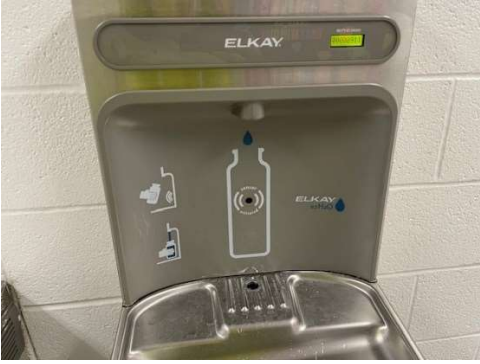
ID:	182-PIM-23	Location:	Hallway		
Photo:

Manufacturer:	Elkay		
		Description:			
		Right double fountain bottle filler next to room 407			
		Result:	<1.0	ppb	
Recommended Action:		Date Sampled:	2/10/2024	By:	BD

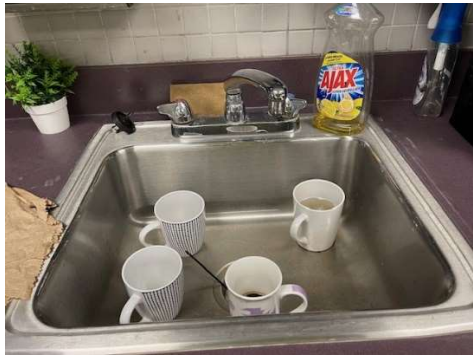
ID:	182-PIM-24	Location:	Teacher's Workroom		
Photo:

Manufacturer:	Unknown		
		Description:			
		Sink			
		Result:	<1.0	ppb	
Recommended Action:		Date Sampled:	2/10/2024	By:	BD

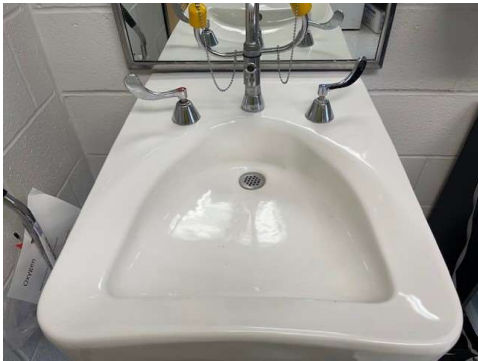
ID:	182-PIM-25	Location:	Nurse's office		
Photo:

Manufacturer:	Unknown		
		Description:			
		Sink			
		Result:	<1.0	ppb	
Recommended Action:		Date Sampled:	2/10/2024	By:	BD

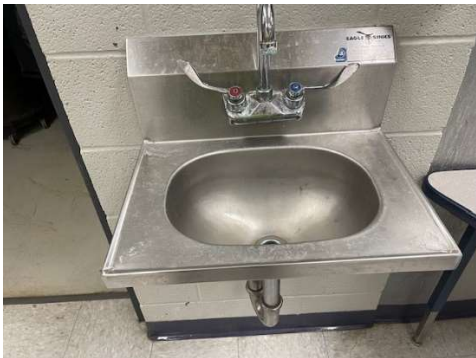
ID:	182-PIM-27	Location:	Kitchen		
Photo:

Sample ID	Location	Type	Result (ug/L)
182-PIM-27	Kitchen	Handwashing Sink	5.4
182-PIM-35	Kitchen	Kitchen Dish Sprayer	N/A
182-PIM-36	Kitchen	Sink	27
182-PIM-37	Kitchen	Sink	N/A
182-PIM-40	Baseball Concessions	Sink	10.6
182-PIM-41	Baseball Concessions	Sink	23

Manufacturer:	Unknown		
		Description:			
		Handwashing station on West wall			
		Result:	5.4	ppb	
Recommended Action:		Date Sampled:	2/10/2024	By:	BD
		Replace Fixture/Unit and Resample

In accordance with the requirements set forth in Missouri Bill 681/662, fixtures exhibiting lead concentrations above 5 ppb must be remediated by replacement of lead-containing pipes, solder, fittings or fixtures with lead-free components, or the school shall install filtration at each point where water enters the building until such time as the source can be remediated. If installing a filter is not feasible, the school shall provide purified water at each outlet inventoried.

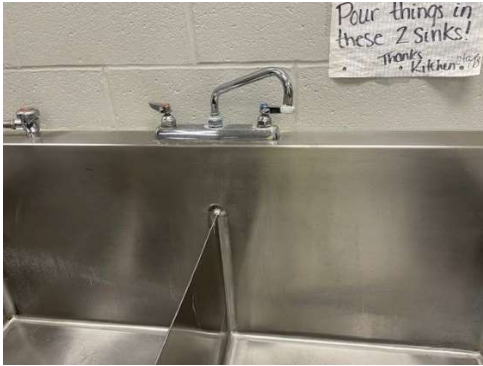
ID:	182-PIM-28	Location:	Kitchen		
Photo:

Manufacturer:	T&S Brass		
		Description:			
		South wall right sink			
		Result:	1.7	ppb	
Recommended Action:		Date Sampled:	2/10/2024	By:	BD

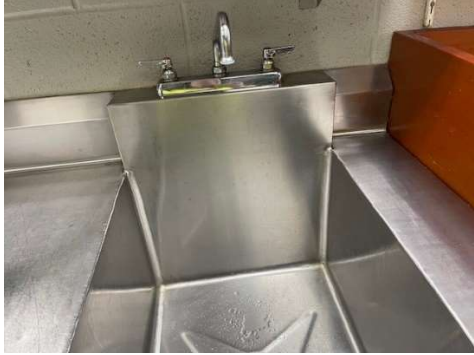
ID:	182-PIM-29	Location:	Kitchen		
Photo:

Manufacturer:	T&S Brass		
		Description:			
		left sink			
		Result:	1.3	ppb	
Recommended Action:		Date Sampled:	2/10/2024	By:	BD

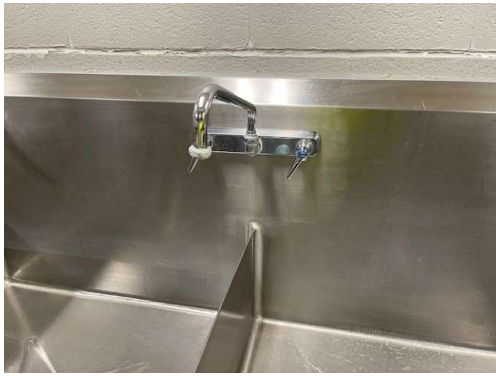
ID:	182-PIM-30	Location:	Kitchen		
Photo:

Manufacturer:	Unknown		
		Description:			
		Pot Filler			
		Result:	3	ppb	
Recommended Action:		Date Sampled:	2/10/2024	By:	BD

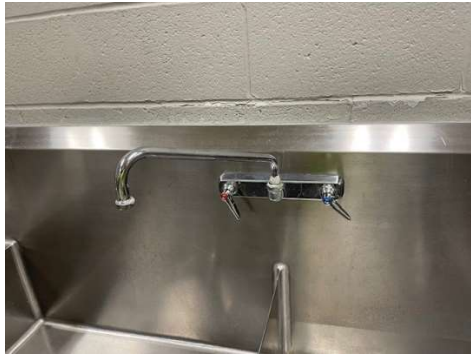
ID:	182-PIM-31	Location:	Kitchen	
Photo:

Manufacturer:	T&S Brass	
		Description:		
		North wall right sink		
		Result:	1.1	ppb
Recommended Action:		Date Sampled:	2/10/2024	By: BD

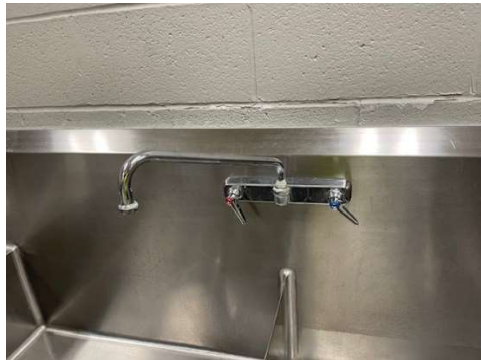
ID:	182-PIM-32	Location:	Kitchen	
Photo:

Manufacturer:	T&S Brass	
		Description:		
		Middle sink		
		Result:	1.3	ppb
Recommended Action:		Date Sampled:	2/10/2024	By: BD

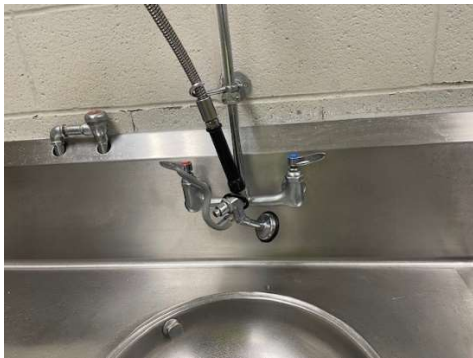
ID:	182-PIM-33	Location:	Kitchen	
Photo:

Manufacturer:	T&S Brass	
		Description:		
		left Kitchen dish sprayer		
		Result:	2.7	ppb
Recommended Action:		Date Sampled:	2/10/2024	By: BD

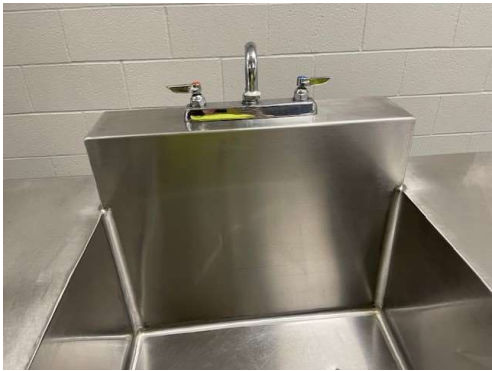
ID:	182-PIM-34	Location:	Kitchen	
Photo:

Manufacturer:	T&S Brass	
		Description:		
		North side of kitchen sink		
		Result:	<1.0	ppb
Recommended Action:		Date Sampled:	2/10/2024	By: BD

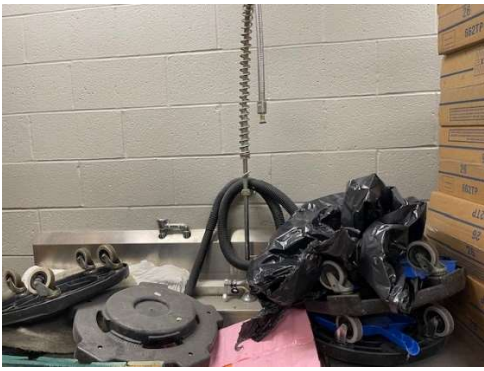
ID:	182-PIM-35	Location:	Kitchen	
Photo:

Manufacturer:	Unknown	
		Description:		
		Kitchen dish sprayer in left room of kitchen.		
		Not working at time of test		
Recommended Action:		Result:	N/A	ppb
		Date Sampled:	2/10/2024	By: BD

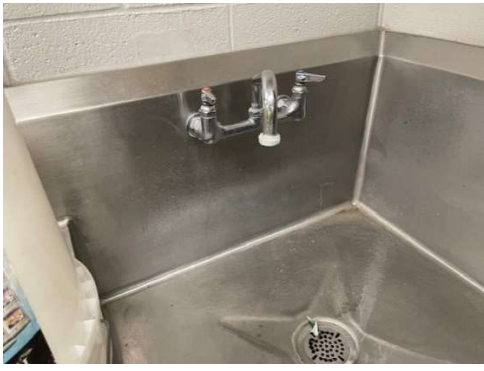
ID:	182-PIM-36	Location:	Kitchen	
Photo:

Manufacturer:	T&S Brass	
		Description:		
		Sink in left room of kitchen		
		Result:	27	ppb
Recommended Action:		Date Sampled:	2/10/2024	By: BD
Replace Fixture/Unit and Resample

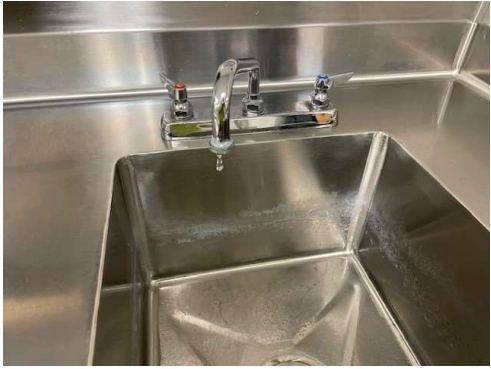
ID:	182-PIM-37	Location:	Kitchen
Photo:

Manufacturer:	T&S Brass
		Description:	
		West sink in front of kitchen.	
		Not working at time of test.	
Result:		N/A	ppb
Date Sampled:		2/10/2024	By: BD
Recommended Action:

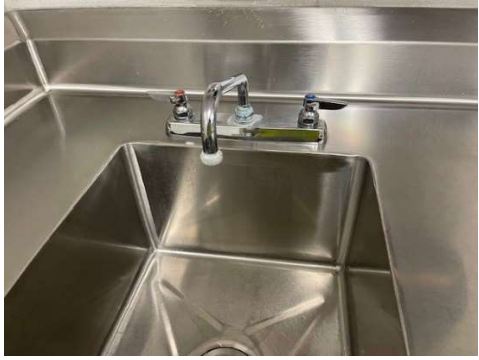
ID:	182-PIM-38	Location:	Kitchen
Photo:

Manufacturer:	T&S Brass
		Description:	
		East sink in front room of kitchen.	
		Result:	
Date Sampled:		2/10/2024	By: BD
Recommended Action:

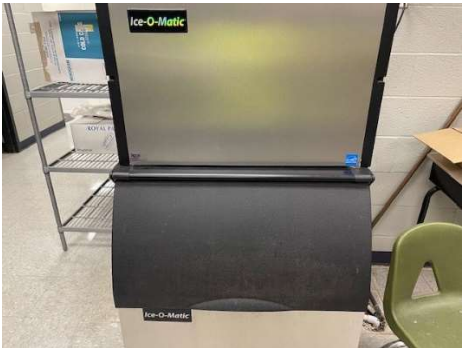
ID:	182-PIM-39	Location:	Kitchen
Photo:

Manufacturer:	Ice-o-matic
		Description:	
		Ice machine	
		Result:	
Date Sampled:		2/10/2024	By: BD
Recommended Action:

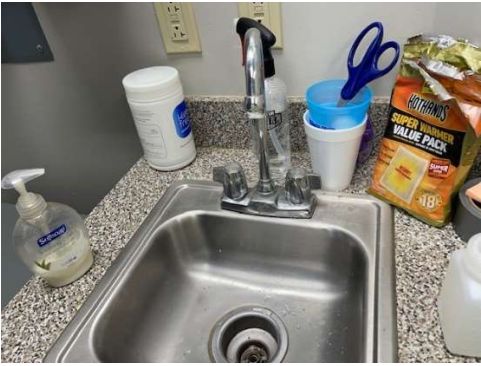
ID:	182-PIM-40	Location:	Baseball Concesions	
Photo:

Manufacturer:	Delta	
		Description:		
		Small sink		
		Result:	10.6	ppb
Recommended Action:		Replace Fixture/Unit and Resample		
		Date Sampled:	2/10/2024	By: BD

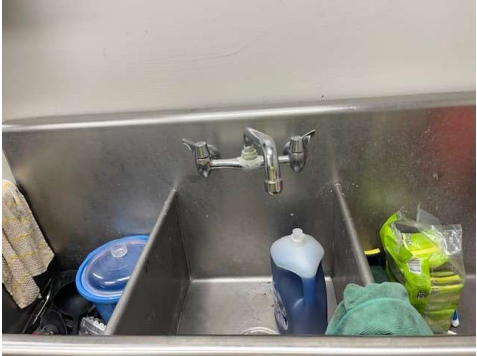
ID:	182-PIM-41	Location:	Baseball Concesions	
Photo:

Manufacturer:	Standard American	
		Description:		
		Big sink		
		Result:	23	ppb
Recommended Action:		Replace Fixture/Unit and Resample		
		Date Sampled:	2/10/2024	By: BD
