RE: Drinking Water Sampling – John Evans Middle School
303 S Lead St, Potosi, MO 63664
Project Number: 923182

Drinking Water Assessment
Potosi Middle School
Potosi School District

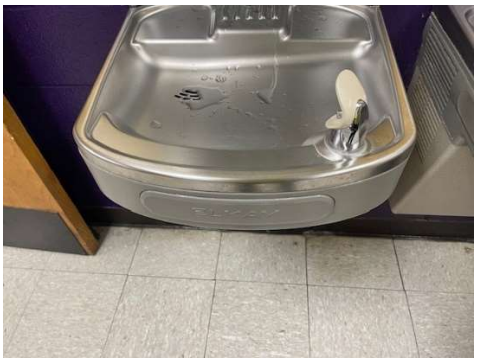
ID:	182-PMS-02	Location:	Hallway	
Photo:

Manufacturer:	Elkay	
		Description:		
		In front of oncession stand, left drinking fountain bubbler		
		Result:	<1.0	ppb
		Date Sampled:	2/10/2024	By: BD
Recommended Action:

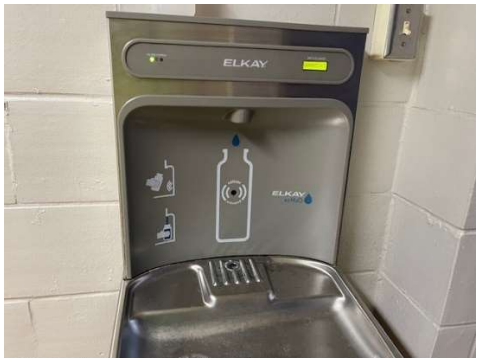
ID:	182-PMS-15	Location:	Cafeteria	
Photo:

Manufacturer:	Elkay	
		Description:		
		Water bottle filler		
		Result:	<1.0	ppb
		Date Sampled:	2/10/2024	By: BD
Recommended Action:
